Manhole Inspection Summary

Manhole # S31G__013MH

Insp Date: **8/11/08 11:21 AM**

Location Address: **10 w baltimore st**

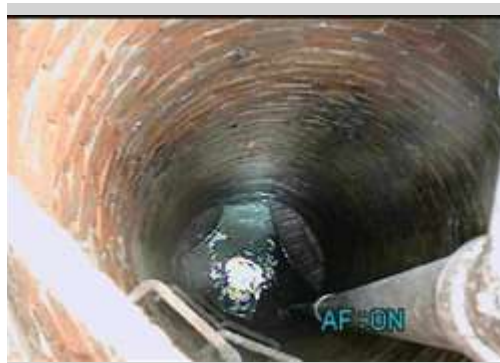
Top View

Top view & steps

cap on top of pipe @ 5

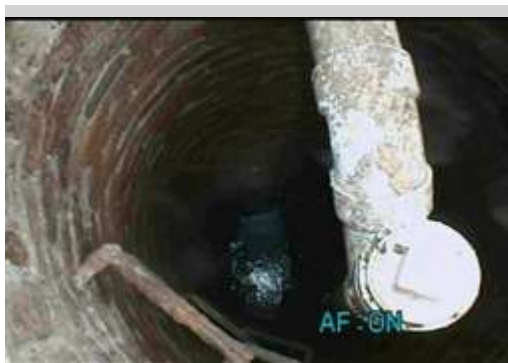
Defect 2

Infiltration: ☐ None ☐ Joint ☐ Cracks ☐ Mortar ☐ Roots ☒ **Wall**

Count: **13** Missing: **0** ☒ **Corroded**

corroded steps, infiltration in barrel wall

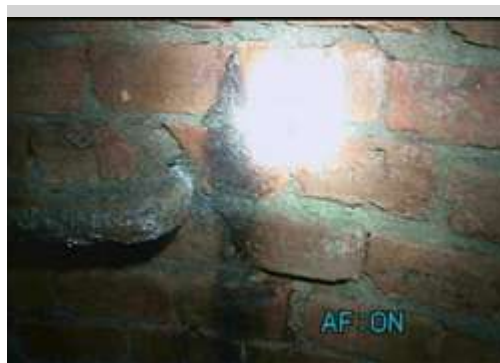
Defect 1

Offset: **3** (in.)

offset

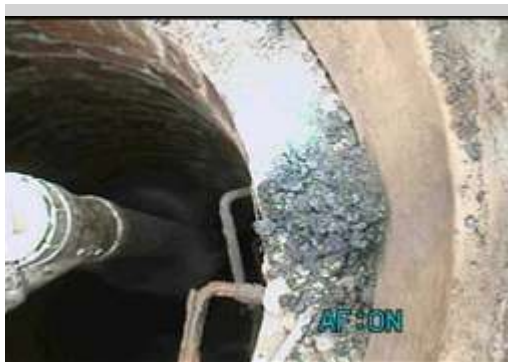
Defect 3

Condition: ☐ Sound ☐ Cracked ☐ Root Intrusion ☒ **Loose Brick** ☐ Deteriorated

chimney loose bricks, frame adj

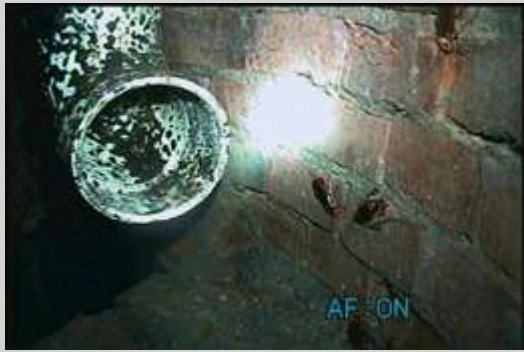
5 O'Clock Inflow

Drop In @ 5 O'Clock

pipe drops inside MH from top of MH down to around 16 feet. There are no other pipes at 5 o'clock.

Drop: Inside	Direct
Angled:	Reading: 0.00 (ft.)
	Inv Depth: 16.75 (ft.)
Drop Condition: Open

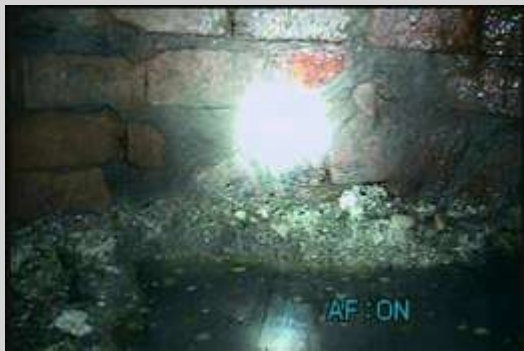
6 O'Clock Inflow

Deposits: ☐ None ☐ Mud ☐ Sludge ☐ Debris ☒ Grease
